EXTreme Window Installation

PROJECT GOAL: Install a motorized shade for heat and UV protection over sliding glass doors on a fifth-floor condo-without obstructing the plantation shutters or the glass windows

LOCATION: Condo in Sarasota, FL

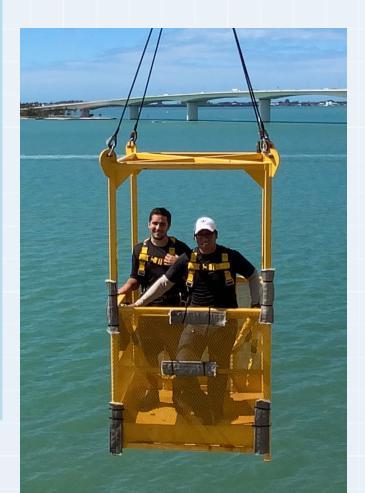
We hired a rigging crew to help assist the crane to lift the materials up to the front of the condo and we hand-loaded them off the rigging into the hallway, then out to the back balcony. Once all the materials were on the fifth floor, the crane dropped the man

basket down behind the building for the installers, Dylan (my son) and Marcos. With safety harnesses clipped, they were hoisted up to the fifth floor. The rest of the team held the tools and basket in place to prevent it from banging against the railing. Tools and fasteners were handed up as needed as they carefully installed the aluminum housing and roller onto the exterior of the condo. The installers were then moved to the left and right sides of the 16-footwide opening to attach the tracking to the walls.
